Flood Control Project Maintenance
Levee Inspections

Fall 2013 Levee Maintenance Deficiency Summary Report

Sacramento River Basin

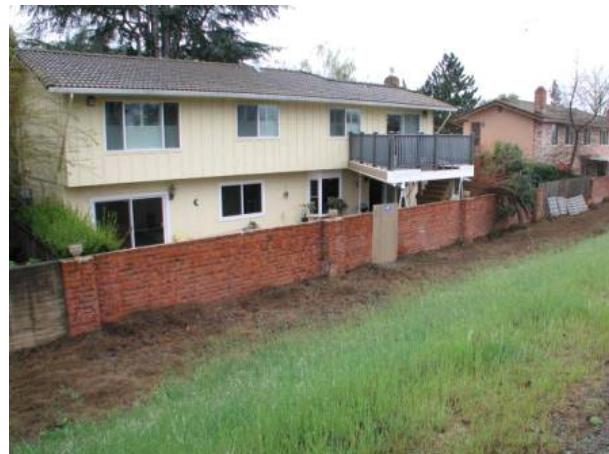
Levee Mile Report Line	133
Start Levee Mile	8.13
End Levee Mile	8.13
Location	Land Side
Category	Earthen Levee
Item	Encroachments
03/16/2012 Brick wall completely obstructs access and visibility.	
mkhashch_f_20130923_939.jpg

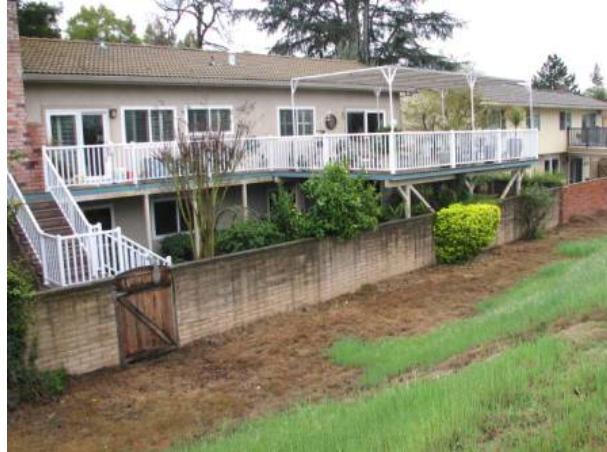
Levee Mile Report Line	134
Start Levee Mile	8.14
End Levee Mile	8.14
Location	Land Side
Category	Earthen Levee
Item	Encroachments
03/16/2012 Brick wall completely obstructs access and visibility.	
mkhashch_f_20130923_940.jpg

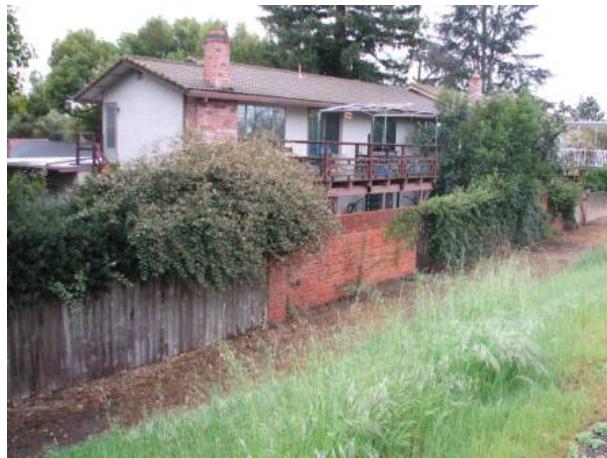
Levee Mile Report Line	135
Start Levee Mile	8.15
End Levee Mile	8.15
Location	Land Side
Category	Earthen Levee
Item	Encroachments
03/16/2012 Brick wall completely obstructs access and visibility.	
mkhashch_f_20130923_941.jpg

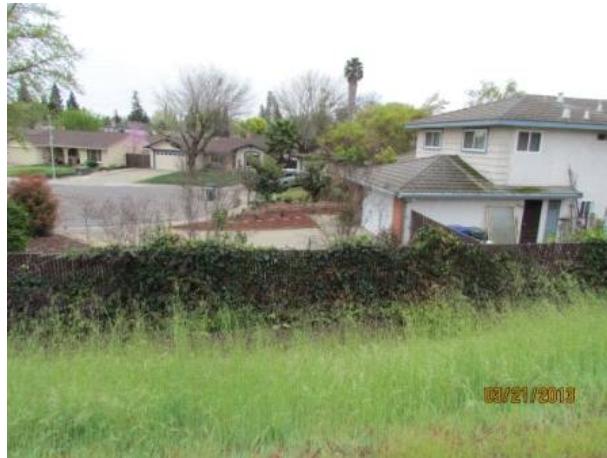
Levee Mile Report Line	136
Start Levee Mile	8.19
End Levee Mile	8.19
Location	Land Side
Category	Earthen Levee
Item	Vegetation
View of the landscaping at the levee toe.	
mkhashch_f_20130923_053.JPG

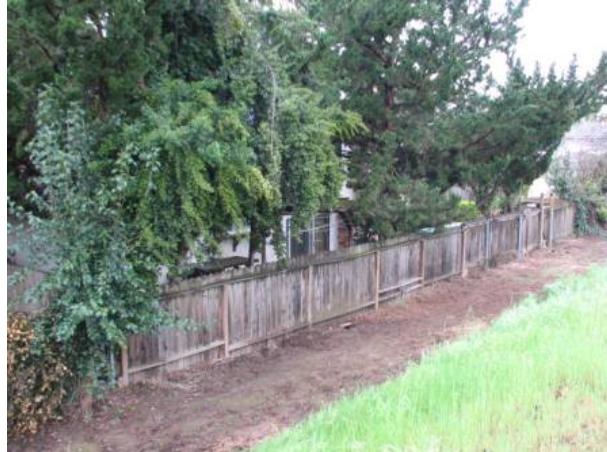
Levee Mile Report Line	137
Start Levee Mile	8.22
End Levee Mile	8.22
Location	Land Side
Category	Earthen Levee
Item	Encroachments
03/16/2012 Wood privacy fence completely obstructs access and visibility.	
mkhashch_f_20130923_943.jpg

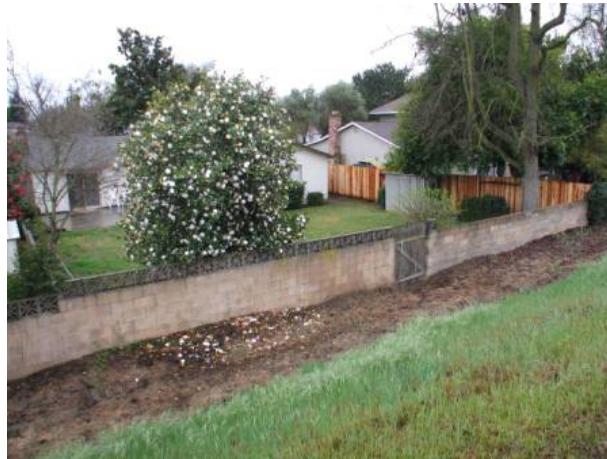
Levee Mile Report Line	138
Start Levee Mile	8.23
End Levee Mile	8.23
Location	Land Side
Category	Earthen Levee
Item	Encroachments
03/16/2012 Cinder block wall completely obstructs access and visibility.	
mkhashch_f_20130923_944.jpg

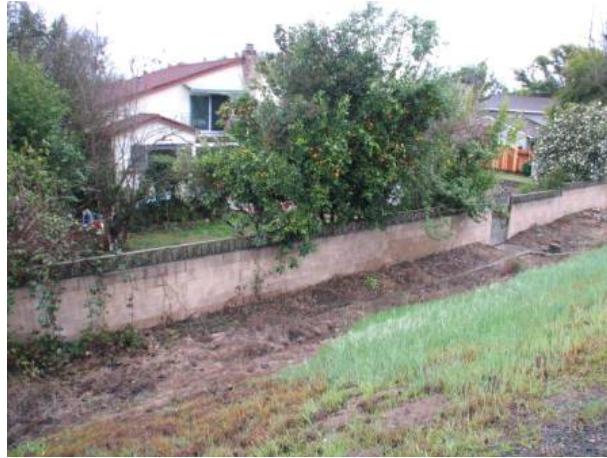
Levee Mile Report Line	139
Start Levee Mile	8.25
End Levee Mile	8.25
Location	Land Side
Category	Earthen Levee
Item	Encroachments
03/16/2012 Cinder block wall completely obstructs access and visibility.	
mkhashch_f_20130923_945.jpg

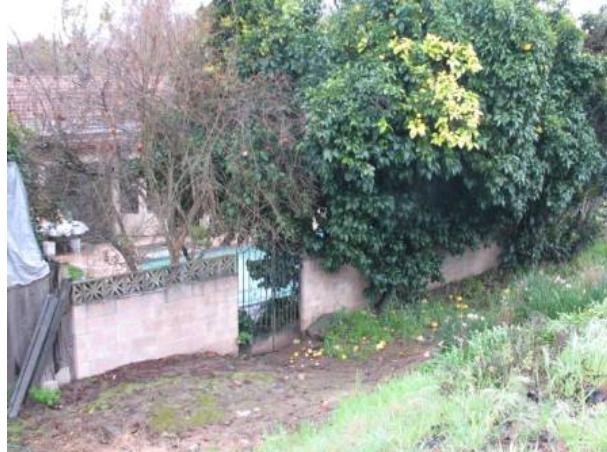
Levee Mile Report Line	140
Start Levee Mile	8.25
End Levee Mile	8.25
Location	Land Side
Category	Earthen Levee
Item	Encroachments
03/16/2012 Cinder block fence completely obstructs access and visibility.	
mkhashch_f_20130923_946.jpg

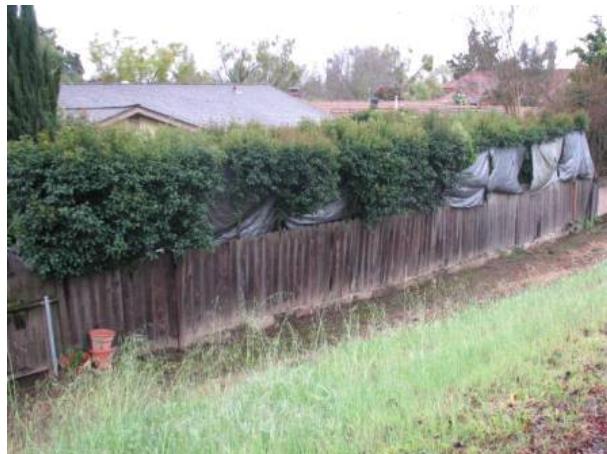
Levee Mile Report Line	141
Start Levee Mile	8.27
End Levee Mile	8.27
Location	Land Side
Category	Earthen Levee
Item	Encroachments
03/16/2012 Wood privacy fence completely obstructs access and visibility.	
mkhashch_f_20130923_947.jpg

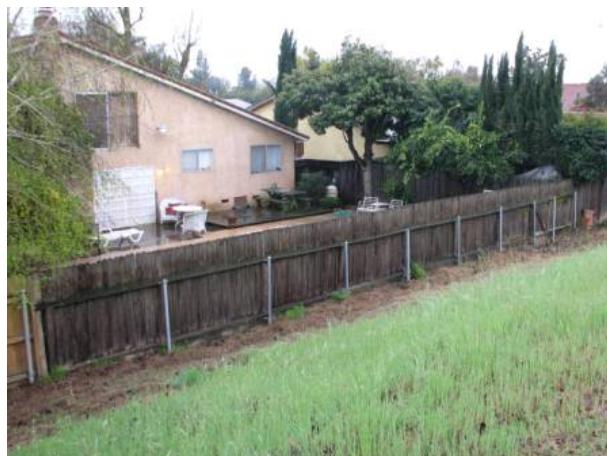
Levee Mile Report Line	142
Start Levee Mile	8.28
End Levee Mile	8.28
Location	Land Side
Category	Earthen Levee
Item	Encroachments
03/16/2012 Wood privacy fence completely obstructs access and visibility.	
mkhashch_f_20130923_948.jpg

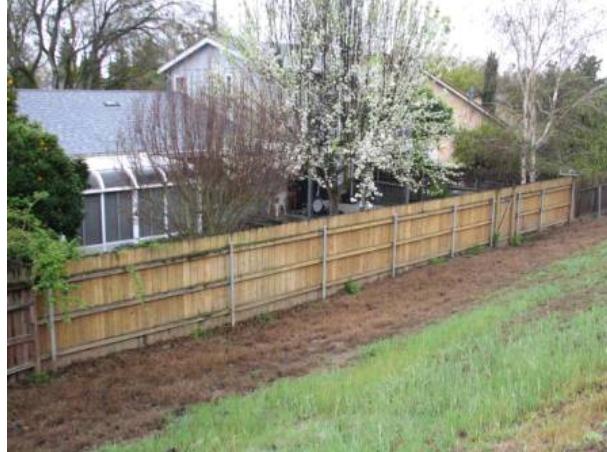
Levee Mile Report Line	143
Start Levee Mile	8.29
End Levee Mile	8.29
Location	Land Side
Category	Earthen Levee
Item	Encroachments
03/16/2012 Wood privacy fence completely obstructs access and visibility.	
mkhashch_f_20130923_949.jpg

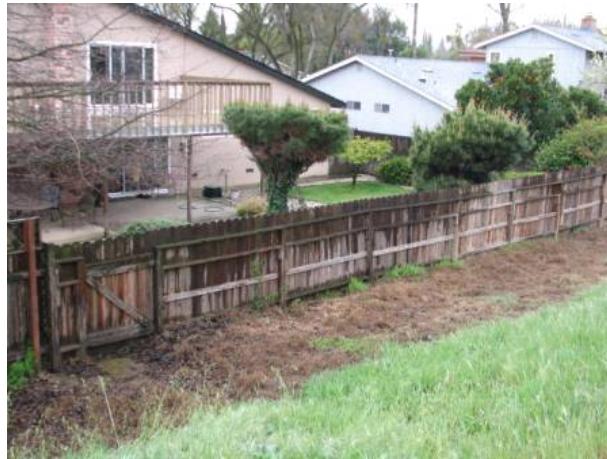
Levee Mile Report Line	144
Start Levee Mile	8.31
End Levee Mile	8.31
Location	Land Side
Category	Earthen Levee
Item	Encroachments
03/16/2012 Wood privacy fence completely obstructs access and visibility.	
mkhashch_f_20130923_951.jpg

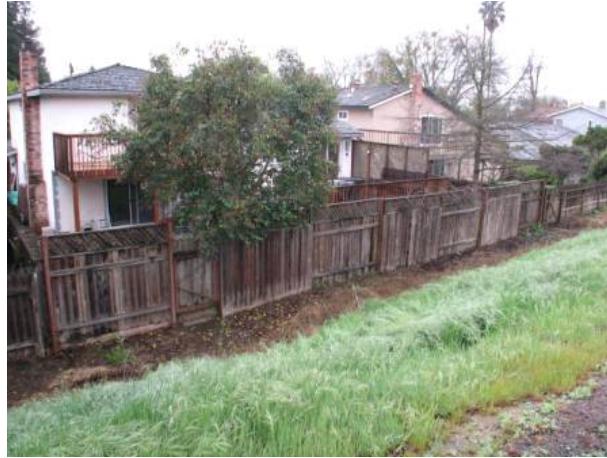
Levee Mile Report Line	145
Start Levee Mile	8.32
End Levee Mile	8.32
Location	Land Side
Category	Earthen Levee
Item	Encroachments
03/16/2012 Wood privacy fence completely obstructs access and visibility.	
mkhashch_f_20130923_952.jpg

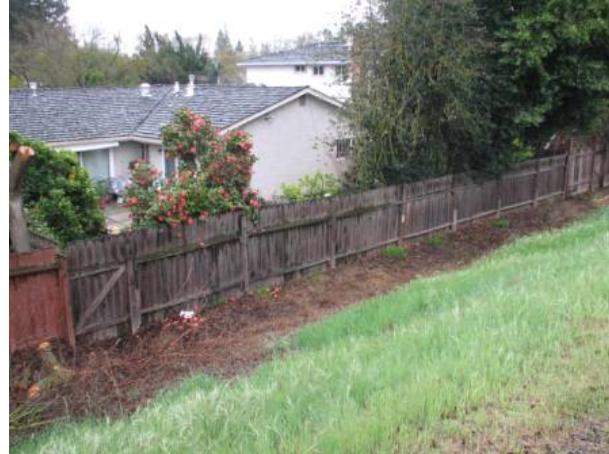
Levee Mile Report Line	146
Start Levee Mile	8.33
End Levee Mile	8.33
Location	Land Side
Category	Earthen Levee
Item	Encroachments
03/16/2012 Wood privacy fence completely obstructs access and visibility.	
mkhashch_f_20130923_953.jpg

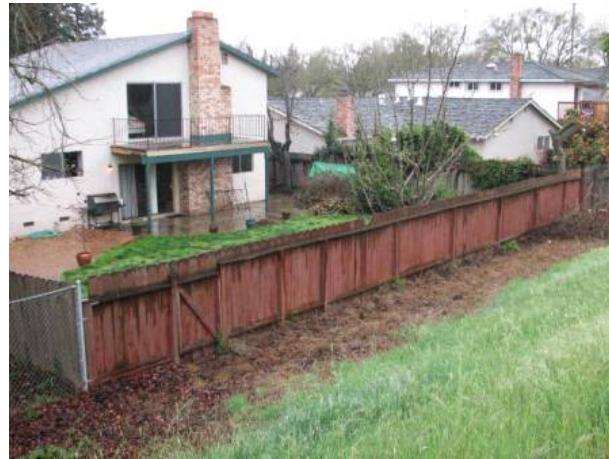
Levee Mile Report Line	148
Start Levee Mile	8.39
End Levee Mile	8.39
Location	Land Side
Category	Earthen Levee
Item	Encroachments
03/16/2012 Wood privacy fence completely obstructs access and visibility.	
mkhashch_f_20130923_955.jpg

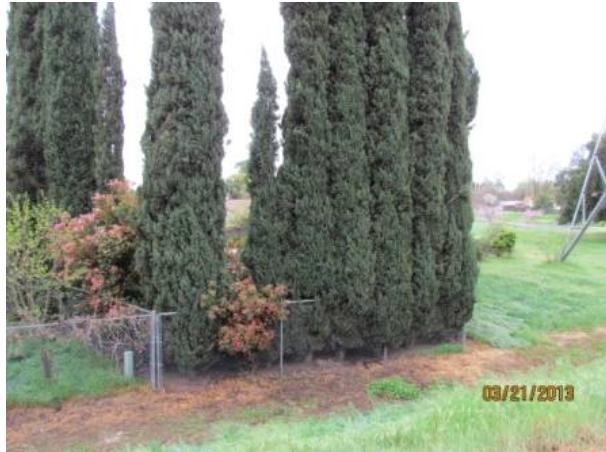
mkhashch_f_20130923_956.JPG

View of the landscaping at the levee toe.

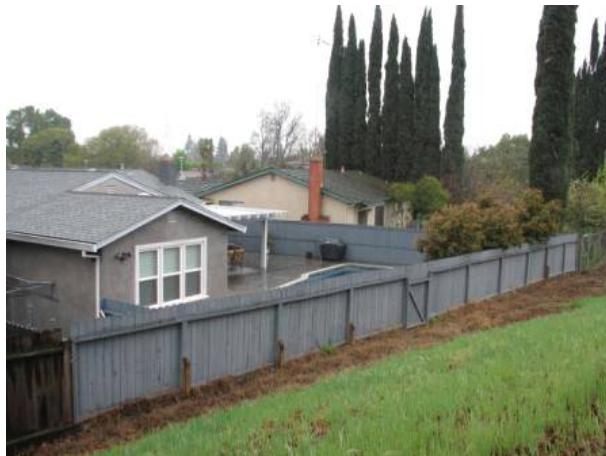
mkhashch_f_20130923_957.jpg

Levee Mile Report Line	150
Start Levee Mile	8.47
End Levee Mile	8.47
Location	Land Side
Category	Earthen Levee
Item	Encroachments

03/16/2012 Wood privacy fence completely obstructs access and visibility.

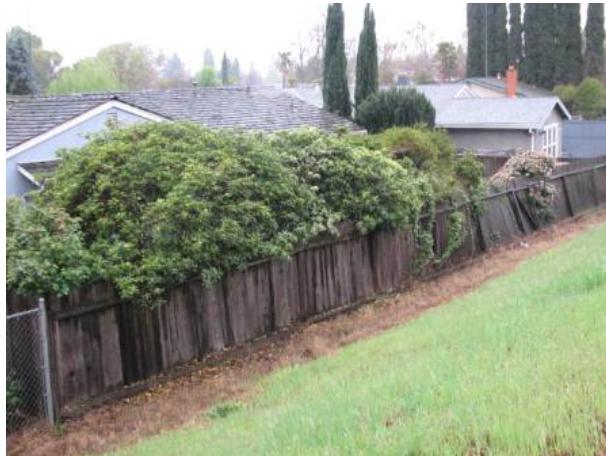
mkhashch_f_20130923_958.jpg

Levee Mile Report Line	151
Start Levee Mile	8.48
End Levee Mile	8.48
Location	Land Side
Category	Earthen Levee
Item	Encroachments

03/16/2012 Wood privacy fence completely obstructs access and visibility.

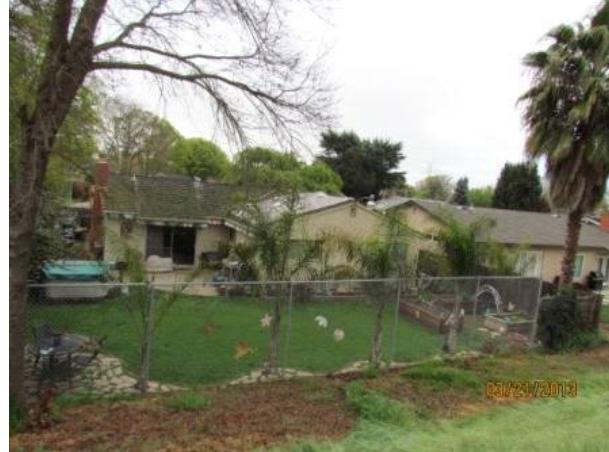
mkhashch_f_20130923_959.JPG

View of the palm trees at the levee toe.

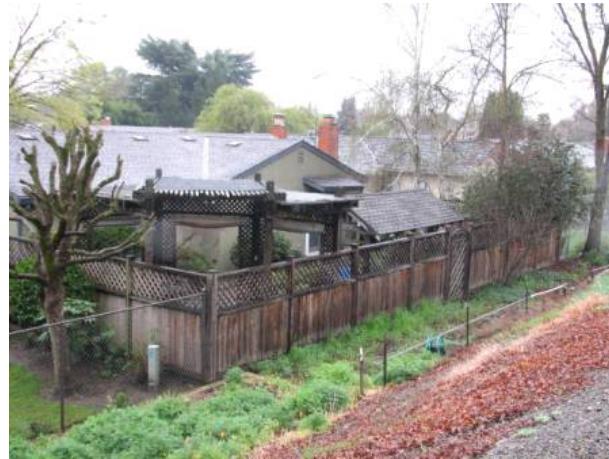
mkhashch_f_20130923_960.jpg

Levee Mile Report Line	153
Start Levee Mile	8.52
End Levee Mile	8.52
Location	Land Side
Category	Earthen Levee
Item	Encroachments

03/16/2012 Wood privacy fence completely obstructs access and visibility.

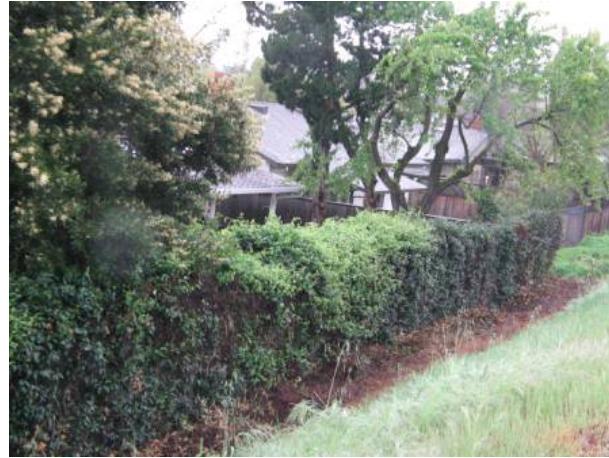
mkhashch_f_20130923_961.jpg

Levee Mile Report Line	154
Start Levee Mile	8.54
End Levee Mile	8.54
Location	Land Side
Category	Earthen Levee
Item	Vegetation

03/16/2012 Landscaping obstructs visibility and access.

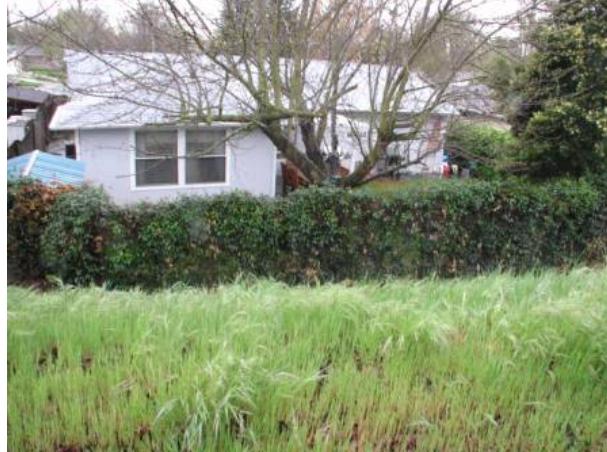
Levee Mile Report Line	155
Start Levee Mile	8.55
End Levee Mile	8.55
Location	Land Side
Category	Earthen Levee
Item	Vegetation
03/16/2012 Landscaping obstructs visibility and access.	
mhashch_f_20130923_962.jpg

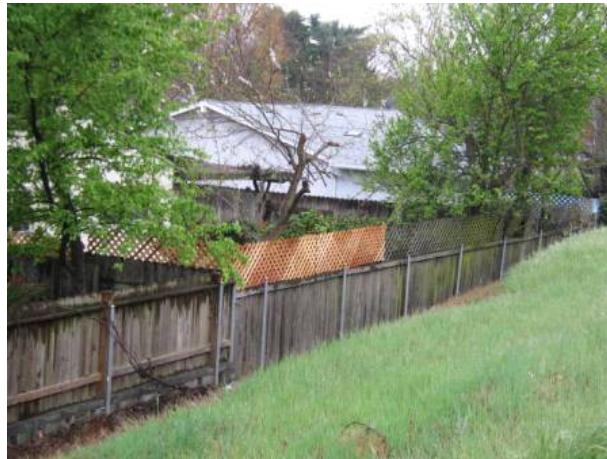
Levee Mile Report Line	157
Start Levee Mile	8.57
End Levee Mile	8.57
Location	Land Side
Category	Earthen Levee
Item	Encroachments
03/16/2012 Wood privacy fence completely obstructs access and visibility.	
mhashch_f_20130923_963.jpg

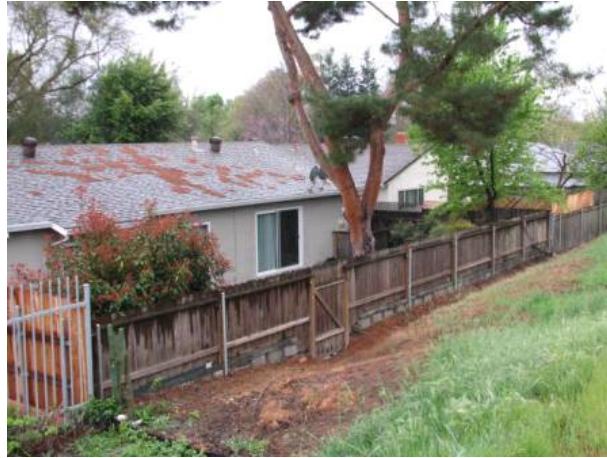
Levee Mile Report Line	158
Start Levee Mile	8.58
End Levee Mile	8.58
Location	Land Side
Category	Earthen Levee
Item	Encroachments
03/16/2012 Wood privacy fence completely obstructs access and visibility.	
mhashch_f_20130923_964.jpg

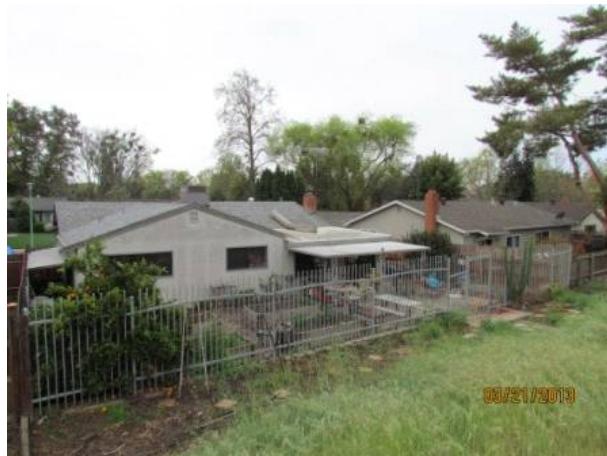
Levee Mile Report Line	159
Start Levee Mile	8.59
End Levee Mile	8.59
Location	Land Side
Category	Earthen Levee
Item	Vegetation

View of landscaping at the levee toe.

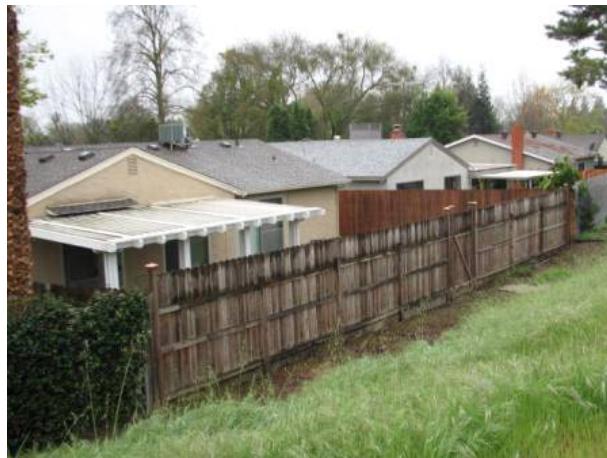
Levee Mile Report Line	160
Start Levee Mile	8.60
End Levee Mile	8.60
Location	Land Side
Category	Earthen Levee
Item	Encroachments

03/16/2012 Wood privacy fence completely obstructs access and visibility.

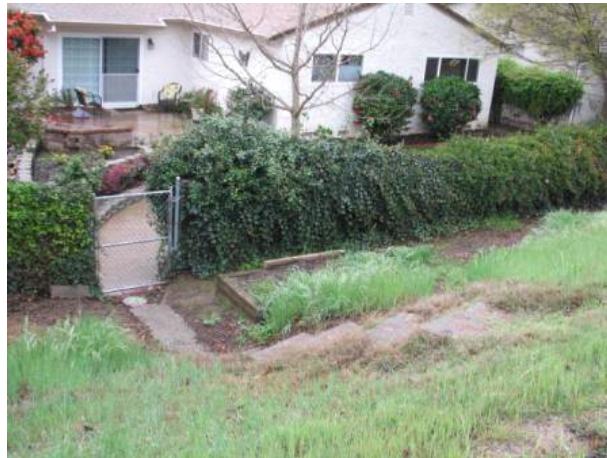
Levee Mile Report Line	161
Start Levee Mile	8.61
End Levee Mile	8.61
Location	Land Side
Category	Earthen Levee
Item	Vegetation

03/16/2012 Landscaping on chainlink fence blocks visibility and access.

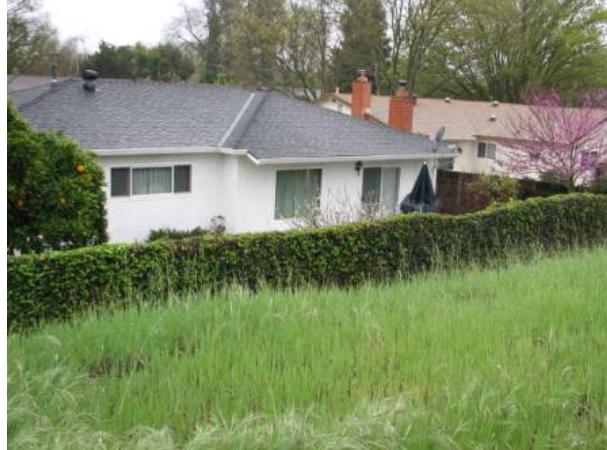
Levee Mile Report Line	162
Start Levee Mile	8.63
End Levee Mile	8.63
Location	Land Side
Category	Earthen Levee
Item	Vegetation
03/16/2012 Ivy on chainlink fence completely obstructs visibility and access.	
mhashch_f_20130923_968.jpg

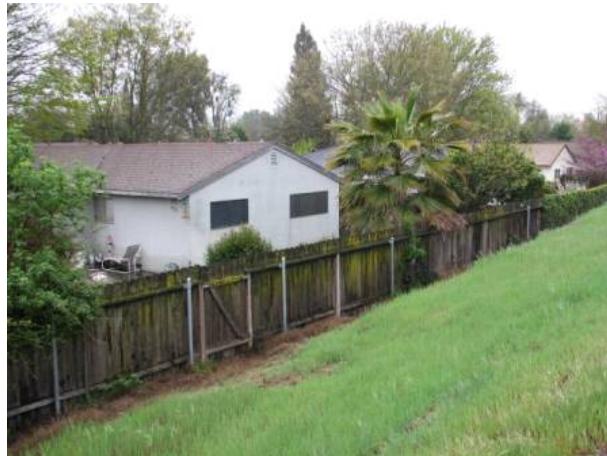
Levee Mile Report Line	163
Start Levee Mile	8.65
End Levee Mile	8.65
Location	Land Side
Category	Earthen Levee
Item	Encroachments
03/16/2012 Wood privacy fence completely obstructs access and visibility.	
mhashch_f_20130923_969.jpg

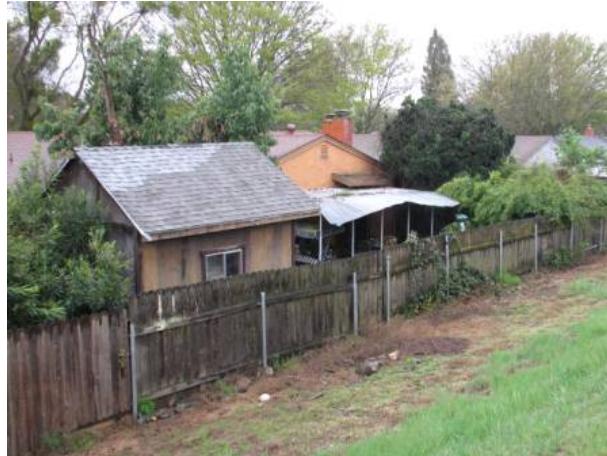
Levee Mile Report Line	164
Start Levee Mile	8.66
End Levee Mile	8.66
Location	Land Side
Category	Earthen Levee
Item	Encroachments
03/16/2012 Wood privacy fence completely obstructs access and visibility.	
mhashch_f_20130923_971.jpg

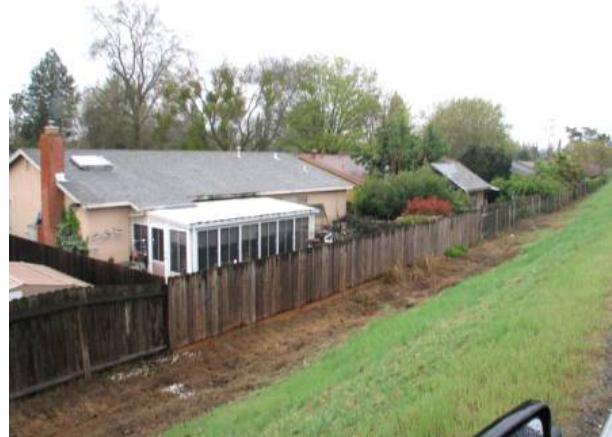
Levee Mile Report Line	165
Start Levee Mile	8.67
End Levee Mile	8.67
Location	Land Side
Category	Earthen Levee
Item	Encroachments
03/16/2012 Wood privacy fence completely obstructs access and visibility.	
mkhashch_f_20130923_970.jpg

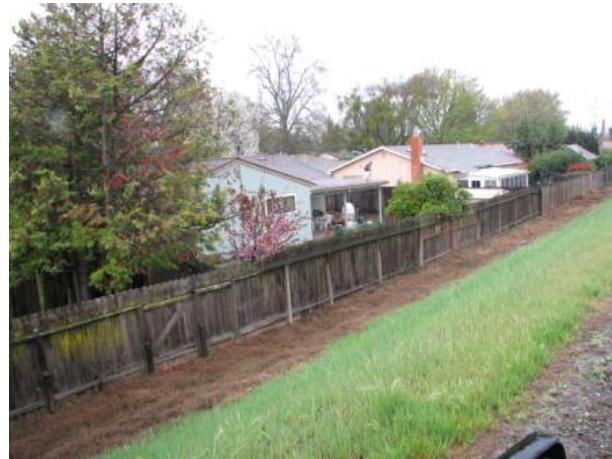
Levee Mile Report Line	166
Start Levee Mile	8.68
End Levee Mile	8.68
Location	Land Side
Category	Earthen Levee
Item	Encroachments
03/16/2012 Wood privacy fence completely obstructs access and visibility.	
mkhashch_f_20130923_972.jpg

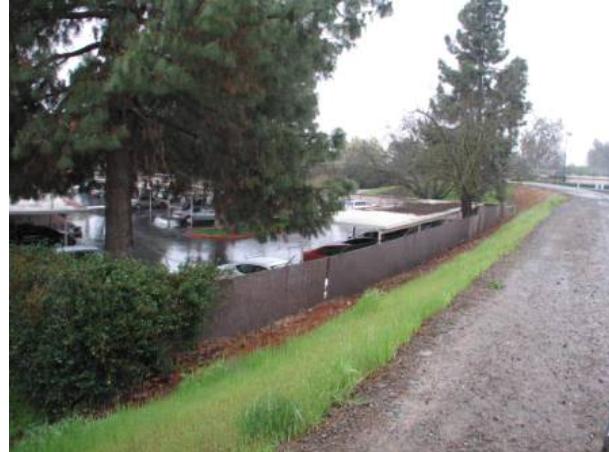
Levee Mile Report Line	168
Start Levee Mile	8.98
End Levee Mile	8.98
Location	Land Side
Category	Earthen Levee
Item	Encroachments
03/16/2012 Chainlink fence with privacy slats and barbed wire obstruct visibility and access.	
mhashch_f_20130923_055.jpg

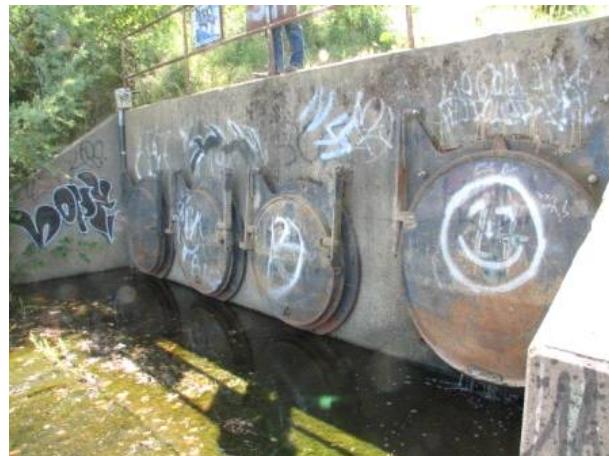
Levee Mile Report Line	169
Start Levee Mile	9.49
End Levee Mile	9.49
Location	Water Side
Category	Earthen Levee
Item	Encroachments
Drainage outfall to American River.	
mhashch_f_20130923_026.jpg

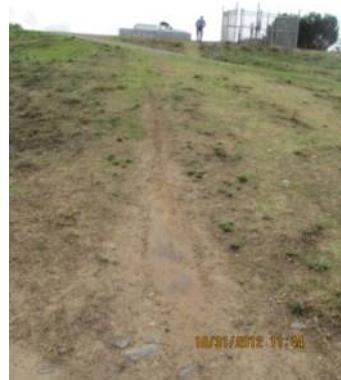
Levee Mile Report Line	169
Start Levee Mile	9.49
End Levee Mile	9.49
Location	Water Side
Category	Earthen Levee
Item	Encroachments
View of exposed pipe at waterside toe.	
mhashch_f_20130923_027.JPG

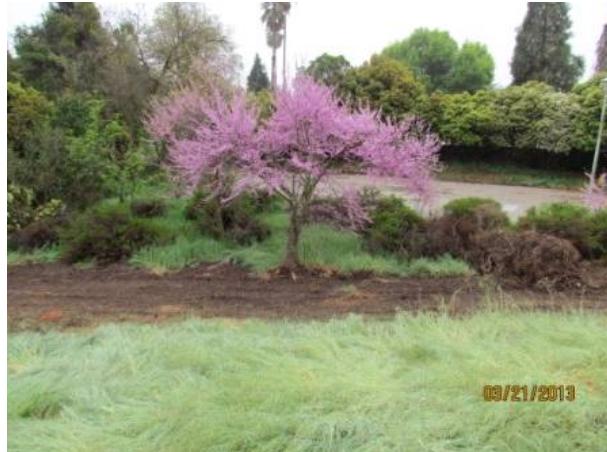
Levee Mile Report Line	170
Start Levee Mile	9.54
End Levee Mile	9.54
Location	Land Side
Category	Earthen Levee
Item	Vegetation
View of landscaping at levee toe in progress of removal by LMA.	
mkhashch_f_20130923_974.JPG

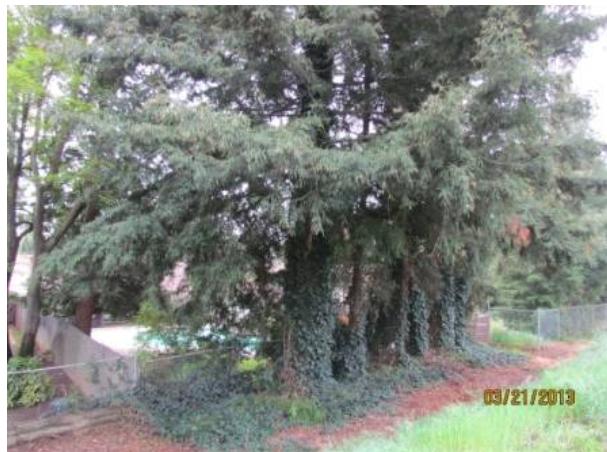
Levee Mile Report Line	171
Start Levee Mile	9.57
End Levee Mile	9.57
Location	Land Side
Category	Earthen Levee
Item	Vegetation
View of landscaping at levee toe.	
mkhashch_f_20130923_056.JPG

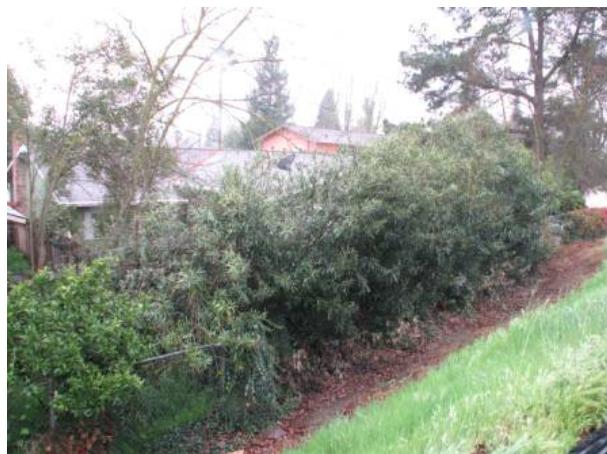
Levee Mile Report Line	172
Start Levee Mile	9.61
End Levee Mile	9.61
Location	Land Side
Category	Earthen Levee
Item	Vegetation
03/16/2012 Landscaping obstructs visibility and access.	
mkhashch_f_20130923_975.jpg

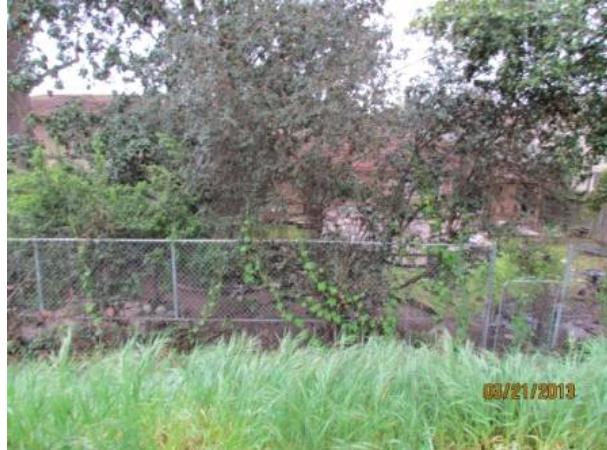
mkhashch_f_20130923_976.JPG

View of landscaping at levee toe.

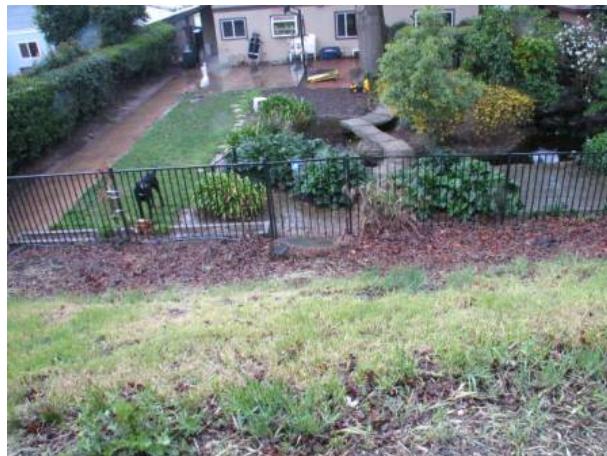
mkhashch_f_20130923_977.jpg

Levee Mile Report Line	175
Start Levee Mile	9.66
End Levee Mile	9.66
Location	Land Side
Category	Earthen Levee
Item	Trim / Thin Trees

03/16/2012 Large tree stump at levee toe.

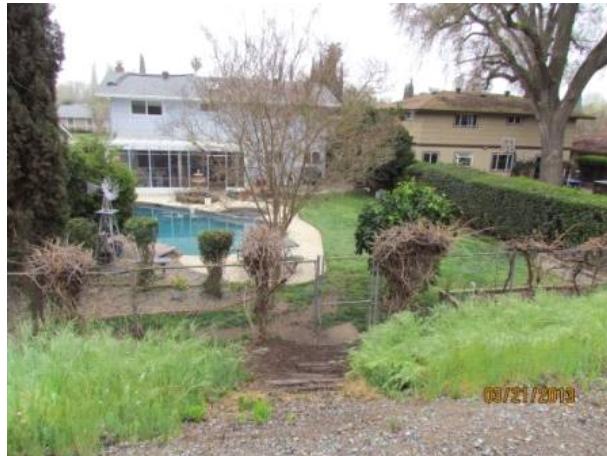
mkhashch_f_20130923_978.JPG

Levee Mile Report Line	176
Start Levee Mile	9.67
End Levee Mile	9.67
Location	Land Side
Category	Earthen Levee
Item	Vegetation

View of landscaping at levee toe.

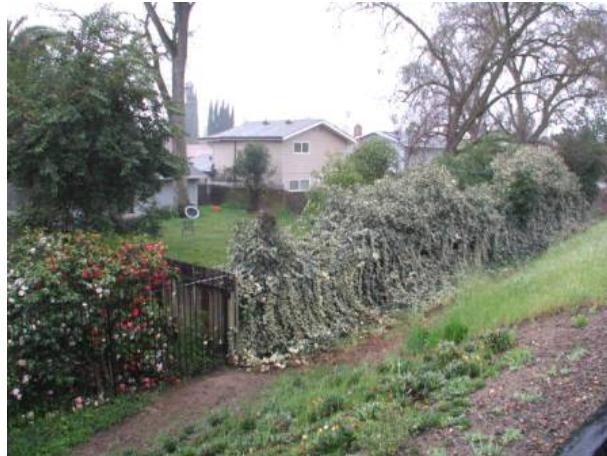
Levee Mile Report Line	177
Start Levee Mile	9.69
End Levee Mile	9.69
Location	Land Side
Category	Earthen Levee
Item	Vegetation
03/16/2012 Landscaping obstructs visibility and access.	
mkhashch_f_20130923_979.jpg

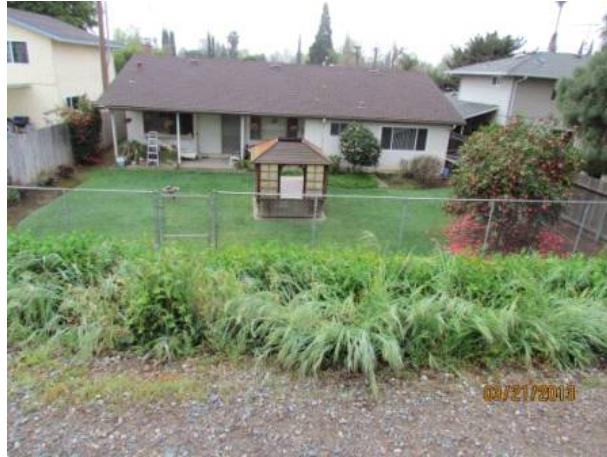
Levee Mile Report Line	179
Start Levee Mile	9.72
End Levee Mile	9.72
Location	Land Side
Category	Earthen Levee
Item	Vegetation
View of landscaping on levee slope.	
mkhashch_f_20130923_980.JPG

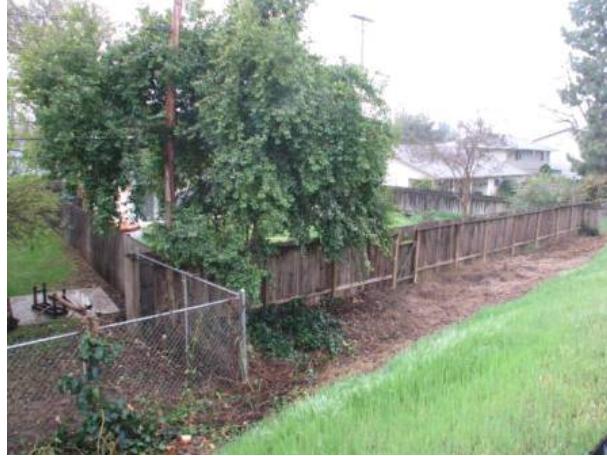
Levee Mile Report Line	180
Start Levee Mile	9.74
End Levee Mile	9.74
Location	Land Side
Category	Earthen Levee
Item	Encroachments
03/16/2012 Wood privacy fence completely obstructs access and visibility.	
mkhashch_f_20130923_981.jpg

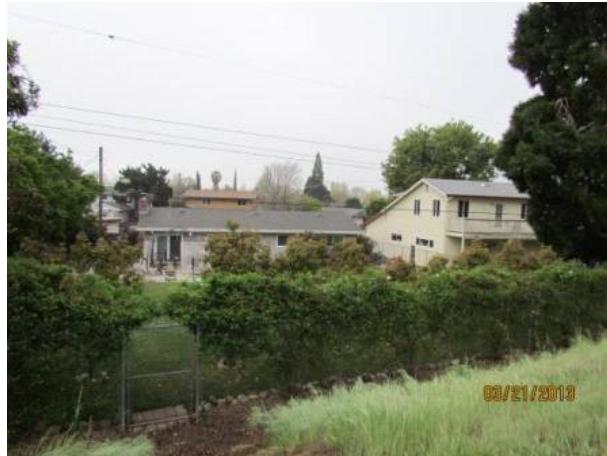
mhashch_f_20130923_982.JPG

View of landscaping at levee toe.

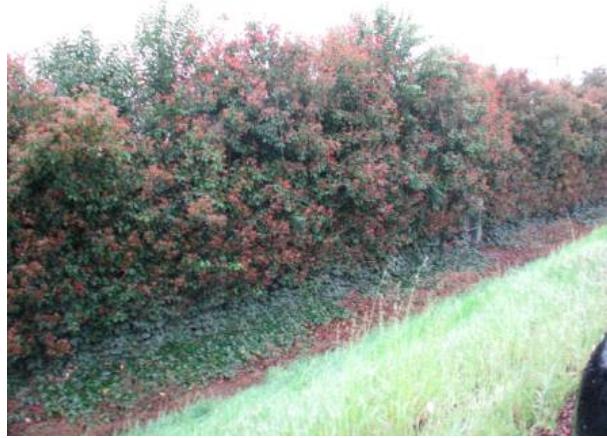
mhashch_f_20130923_983.jpg

Levee Mile Report Line	182
Start Levee Mile	9.78
End Levee Mile	9.78
Location	Land Side
Category	Earthen Levee
Item	Vegetation

03/16/2012 Tall hedge obstructs visibility and access.

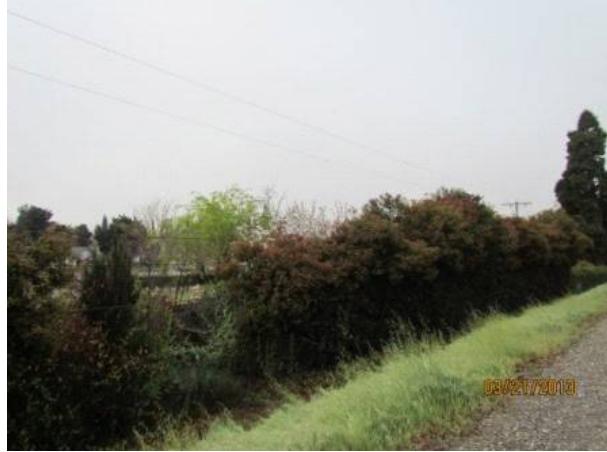
mhashch_f_20130923_984.JPG

Levee Mile Report Line	183
Start Levee Mile	9.79
End Levee Mile	9.79
Location	Land Side
Category	Earthen Levee
Item	Vegetation

View of landscaping at levee toe.

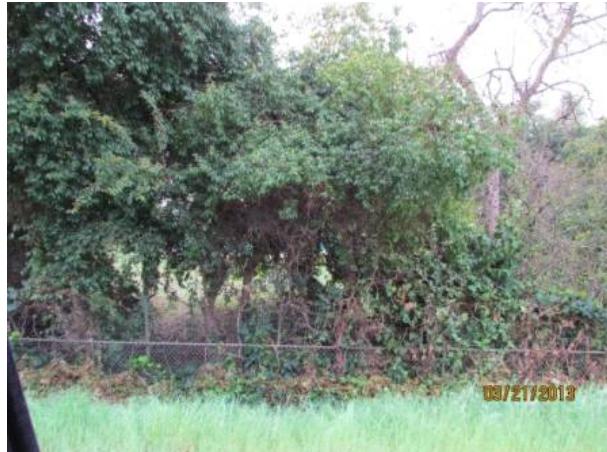
mkhashch_f_20130923_985.JPG

View of obstructive landscaping.

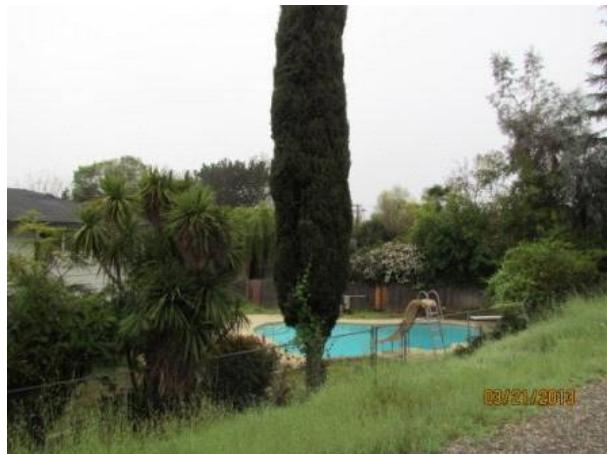
mkhashch_f_20130923_986.JPG

Levee Mile Report Line	185
Start Levee Mile	9.84
End Levee Mile	9.84
Location	Land Side
Category	Earthen Levee
Item	Vegetation

View of landscaping at levee toe.

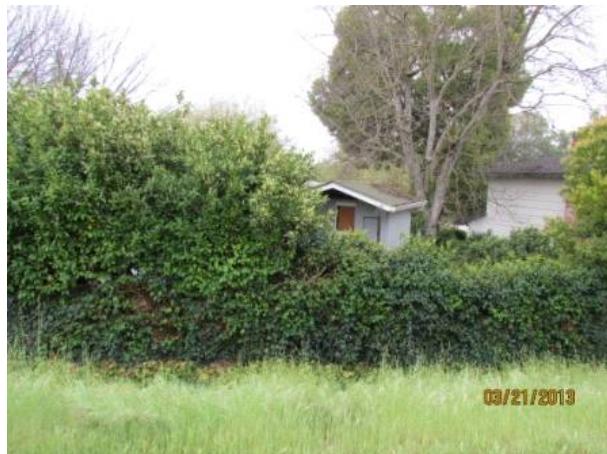
mkhashch_f_20130923_987.JPG

Levee Mile Report Line	186
Start Levee Mile	9.86
End Levee Mile	9.86
Location	Land Side
Category	Earthen Levee
Item	Vegetation

View of landscaping and playhouse.

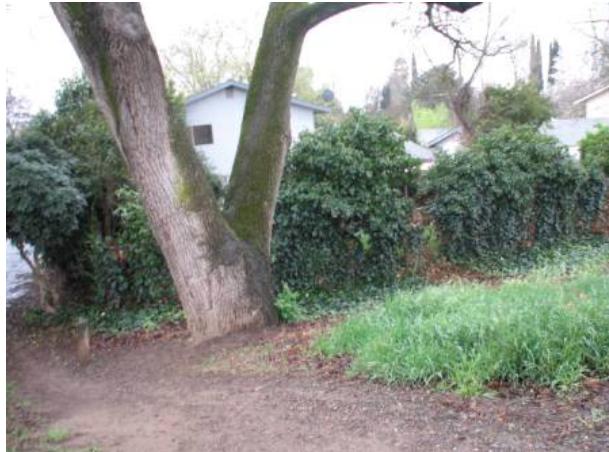
Levee Mile Report Line	187
Start Levee Mile	9.98
End Levee Mile	9.98
Location	Land Side
Category	Earthen Levee
Item	Vegetation
03/16/2012 Landscaping is obstructing visibility.	
mhashch_f_20130923_988.jpg

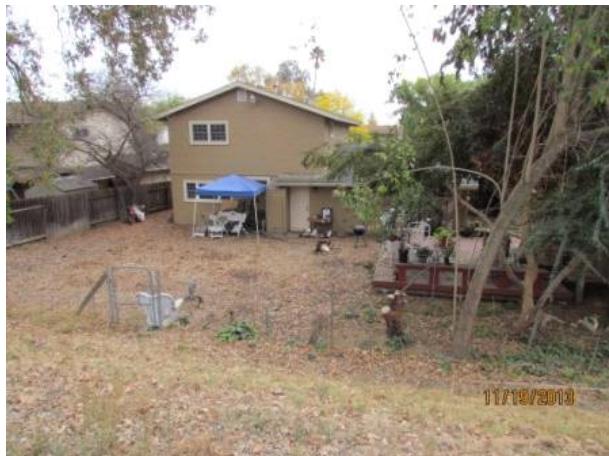
Levee Mile Report Line	188
Start Levee Mile	10.04
End Levee Mile	10.04
Location	Land Side
Category	Earthen Levee
Item	Encroachments
View of the fence and tree stump at the landside levee toe.	
mhashch_f_20131120_724.JPG

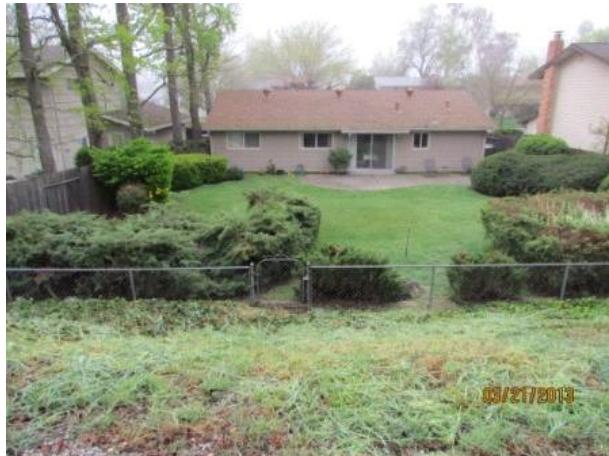
Levee Mile Report Line	190
Start Levee Mile	10.07
End Levee Mile	10.07
Location	Land Side
Category	Earthen Levee
Item	Vegetation
View of encroaching landscaping.	
mhashch_f_20130923_990.JPG

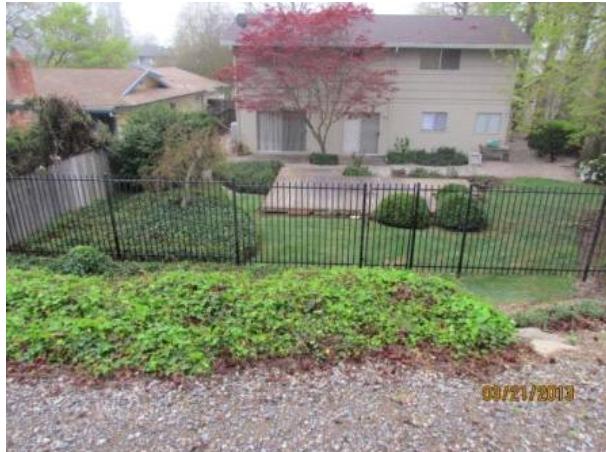
mkhashch_f_20130923_057.JPG

View of the landscaping on levee slope.

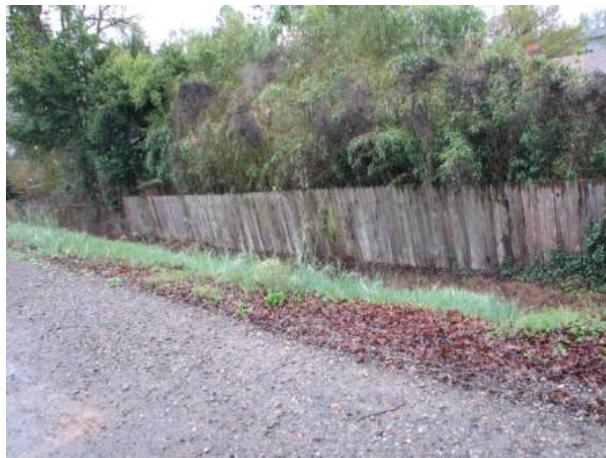
mkhashch_f_20130923_991.jpg

03/16/2012 Wood privacy fence completely obstructs access and visibility.

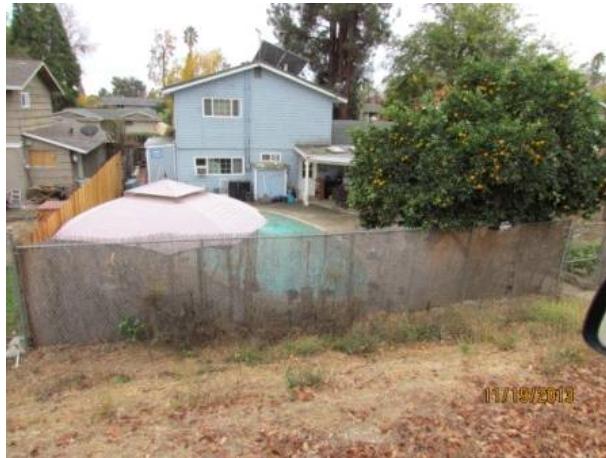
mkhashch_f_20131120_723.JPG

Levee Mile Report Line	193
Start Levee Mile	10.12
End Levee Mile	10.12
Location	Land Side
Category	Earthen Levee
Item	Encroachments

View of the pool filled with water.

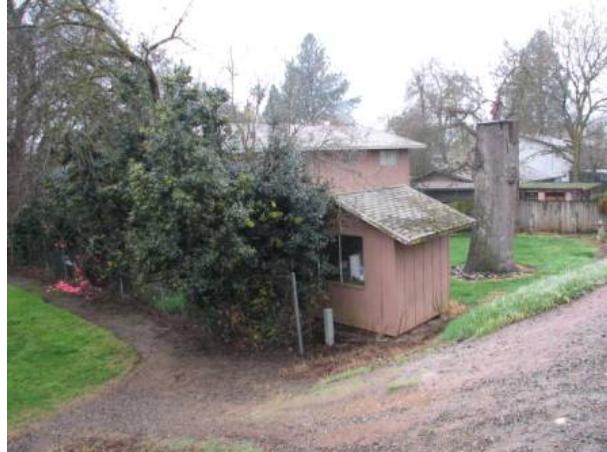
Levee Mile Report Line	194
Start Levee Mile	10.18
End Levee Mile	10.18
Location	Land Side
Category	Earthen Levee
Item	Encroachments
03/16/2012 Wood structure within 15' of levee toe.	
mkhashch_f_20130923_028.jpg

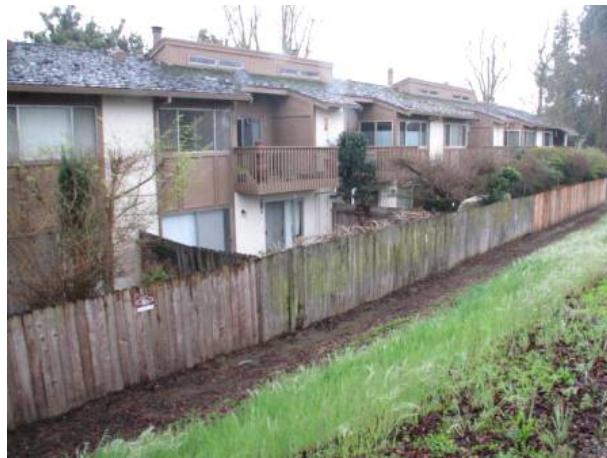
Levee Mile Report Line	195
Start Levee Mile	10.34
End Levee Mile	10.37
Location	Land Side
Category	Earthen Levee
Item	Encroachments
03/16/2012 Wood privacy fence completely obstructs access and visibility.	
mkhashch_f_20130923_994.jpg

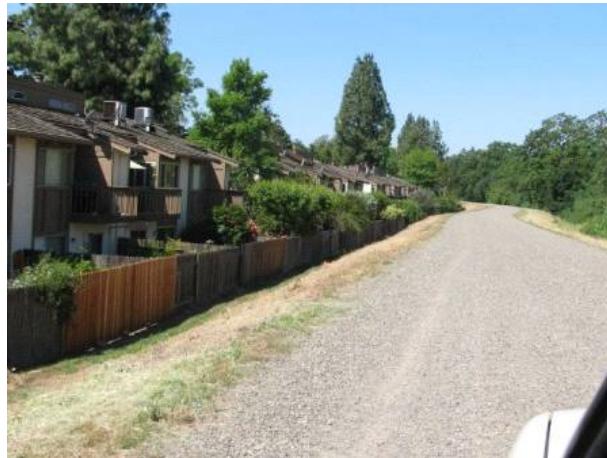
Levee Mile Report Line	196
Start Levee Mile	10.38
End Levee Mile	10.40
Location	Land Side
Category	Earthen Levee
Item	Encroachments
Wooden fence behind apartments within 10' of levee toe.	
mkhashch_f_20130923_995.jpg

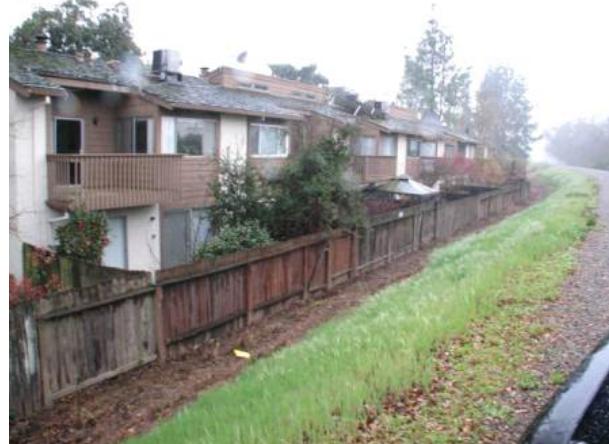
Levee Mile Report Line	197
Start Levee Mile	10.41
End Levee Mile	10.42
Location	Land Side
Category	Earthen Levee
Item	Encroachments
03/16/2012 Wood privacy fence completely obstructs access and visibility.	
mkhashch_f_20130923_999.jpg

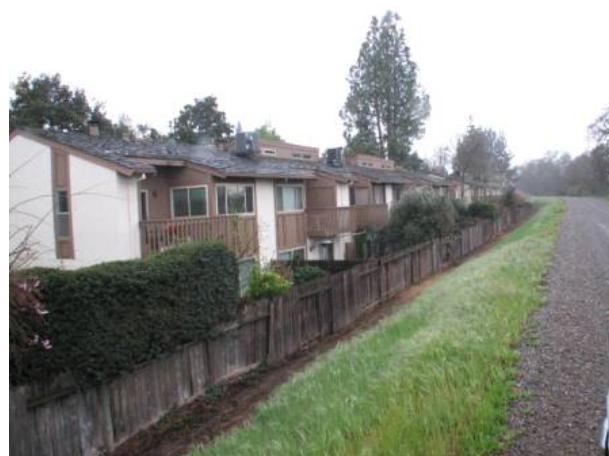
Levee Mile Report Line	198
Start Levee Mile	10.42
End Levee Mile	10.44
Location	Land Side
Category	Earthen Levee
Item	Encroachments
03/16/2012 Wood privacy fence completely obstructs access and visibility.	
mkhashch_f_20130923_996.jpg

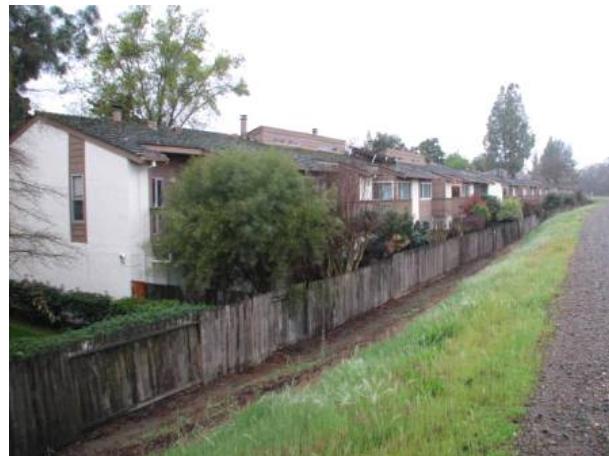
Levee Mile Report Line	199
Start Levee Mile	10.45
End Levee Mile	10.48
Location	Land Side
Category	Earthen Levee
Item	Encroachments
03/16/2012 Wood privacy fence completely obstructs access and visibility.	
mkhashch_f_20130923_997.jpg

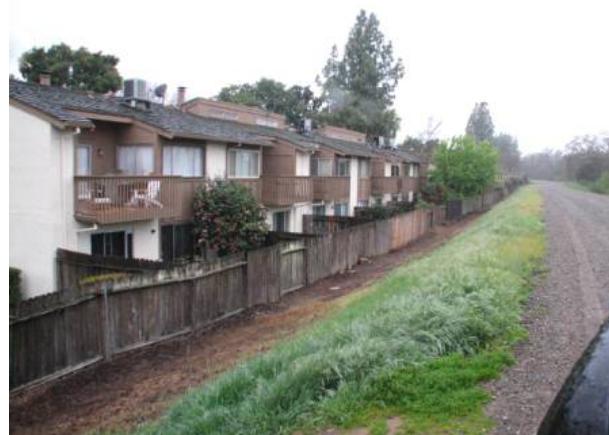
Levee Mile Report Line	200
Start Levee Mile	10.48
End Levee Mile	10.51
Location	Land Side
Category	Earthen Levee
Item	Encroachments
03/16/2012 Wood privacy fence completely obstructs access and visibility.	
mkhashch_f_20130923_998.jpg

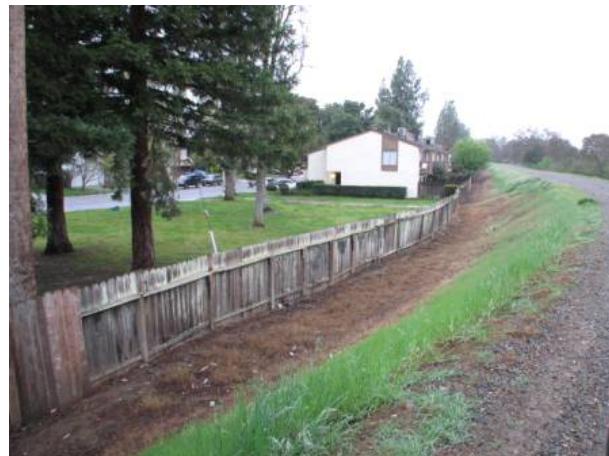
Levee Mile Report Line	201
Start Levee Mile	10.53
End Levee Mile	10.53
Location	Land Side
Category	Earthen Levee
Item	Encroachments
03/16/2012 Wood privacy fence completely obstructs access and visibility.	
mkhashch_f_20130923_000.jpg

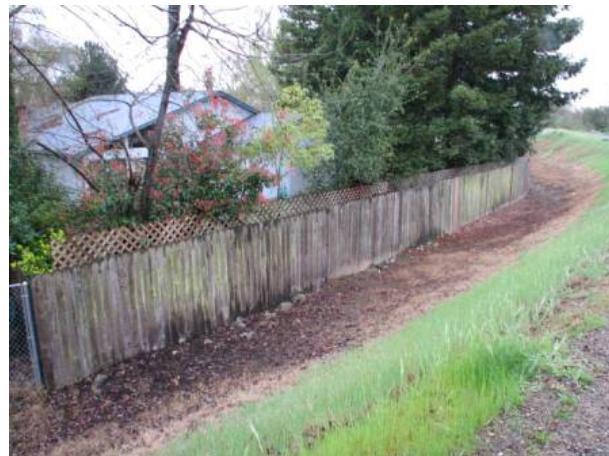
Levee Mile Report Line	202
Start Levee Mile	10.56
End Levee Mile	10.56
Location	Land Side
Category	Earthen Levee
Item	Encroachments
03/16/2012 Wood privacy fence completely obstructs access and visibility.	
mkhashch_f_20130923_001.jpg

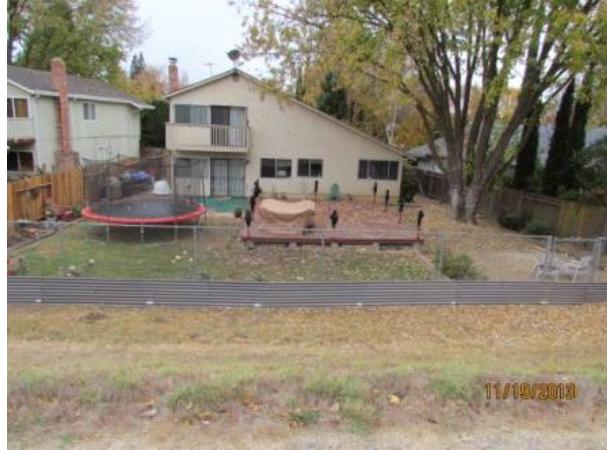
Levee Mile Report Line	203
Start Levee Mile	10.57
End Levee Mile	10.57
Location	Land Side
Category	Earthen Levee
Item	Encroachments
Chainlink fence is partially obstructing visibility and access.	
mkhashch_f_20131120_722.JPG

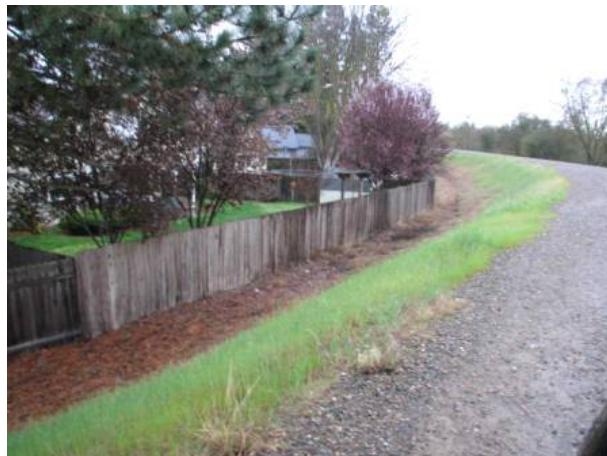
Levee Mile Report Line	204
Start Levee Mile	10.58
End Levee Mile	10.58
Location	Land Side
Category	Earthen Levee
Item	Encroachments
03/16/2012 Wood privacy fence completely obstructs access and visibility.	
mkhashch_f_20130923_002.jpg

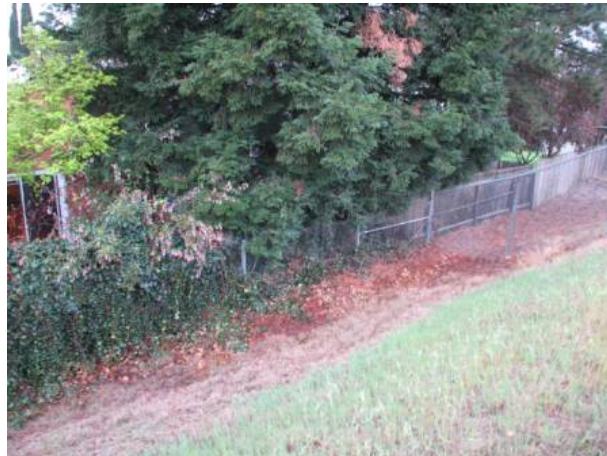
Levee Mile Report Line	205
Start Levee Mile	10.60
End Levee Mile	10.60
Location	Land Side
Category	Earthen Levee
Item	Encroachments
03/16/2012 Wood privacy fence completely obstructs access and visibility.	
mkhashch_f_20130923_003.jpg

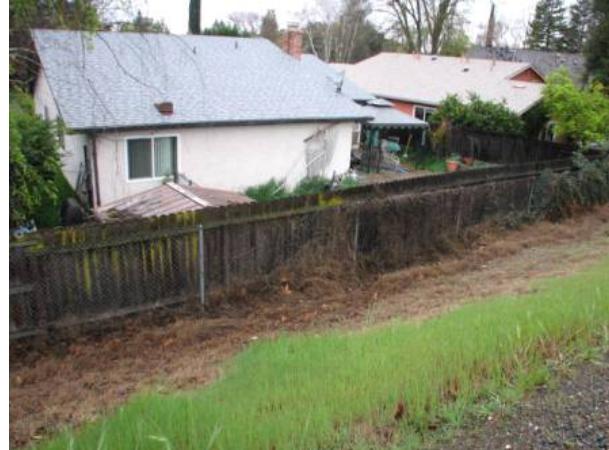
Levee Mile Report Line	206
Start Levee Mile	10.62
End Levee Mile	10.62
Location	Land Side
Category	Earthen Levee
Item	Encroachments
03/16/2012 Wood privacy fence completely obstructs access and visibility.	
mkhashch_f_20130923_004.jpg
